TECHNICAL INSPECTION REPORT

U.S.S. GILLIAM (APA57)

TEST ABLE

OPERATION CROSSROADS

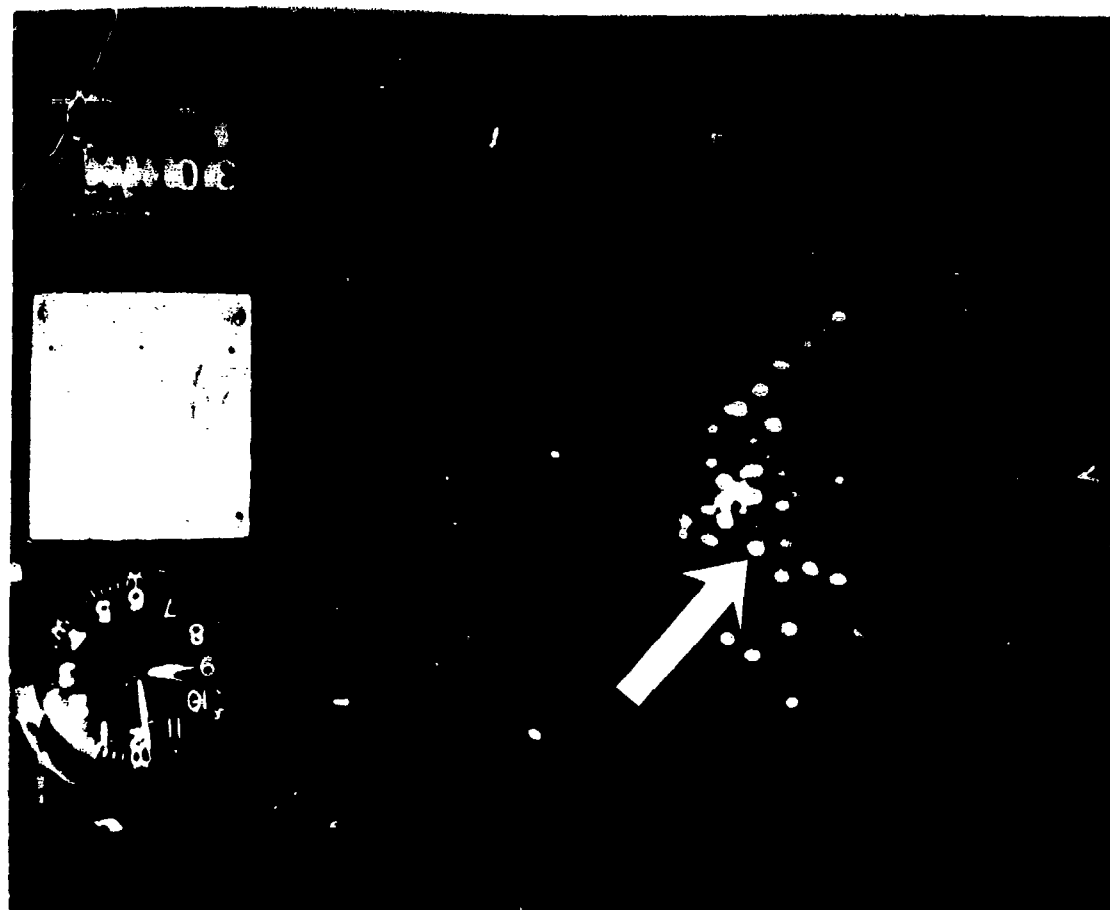
The GILLIAM was sunk. The time and manner of her sinking cannot be stated with certainty. The photo on page 12 shows the target array as seen on APQ #7 radar screen shortly before the burst. The arrow points to the position of the GILLIAM. In the photo on page 13, the GILLIAM appears to have broken into 3 pieces. The two extra images may be echos from large component units which were blown off the GILLIAM. The photo on page 14 shows the GILLIAM going down. She disappears from the radar screen 79 seconds after burst. Presumably the GILLIAM sinks shortly after the photo on page 15 was taken. No further image of the GILLIAM is obtained on the screen. A close scrutiny of the pictures taken by the 24 inch tower cameras on Bikini Island between 42 and 50 seconds after the blast reveal a darker spot in the general haze and smoke covering the array. (See photo on page 16). This spot orientates perfectly with the location of the stern of the GILLIAM just before the blast. Furthermore, it is shaped like the stern of an attack transport inclined upward at about 20 degrees. This spot persists for about four pictures or approximately twelve seconds before it disappears.

APQ #7 Radar Scope Picture #3011. View of target array before burst as seen on APQ #7 #1 radar scope located on Aomoen Island. Burst will occur at clock time of 0900:28. Arrow points to GILLIAM.

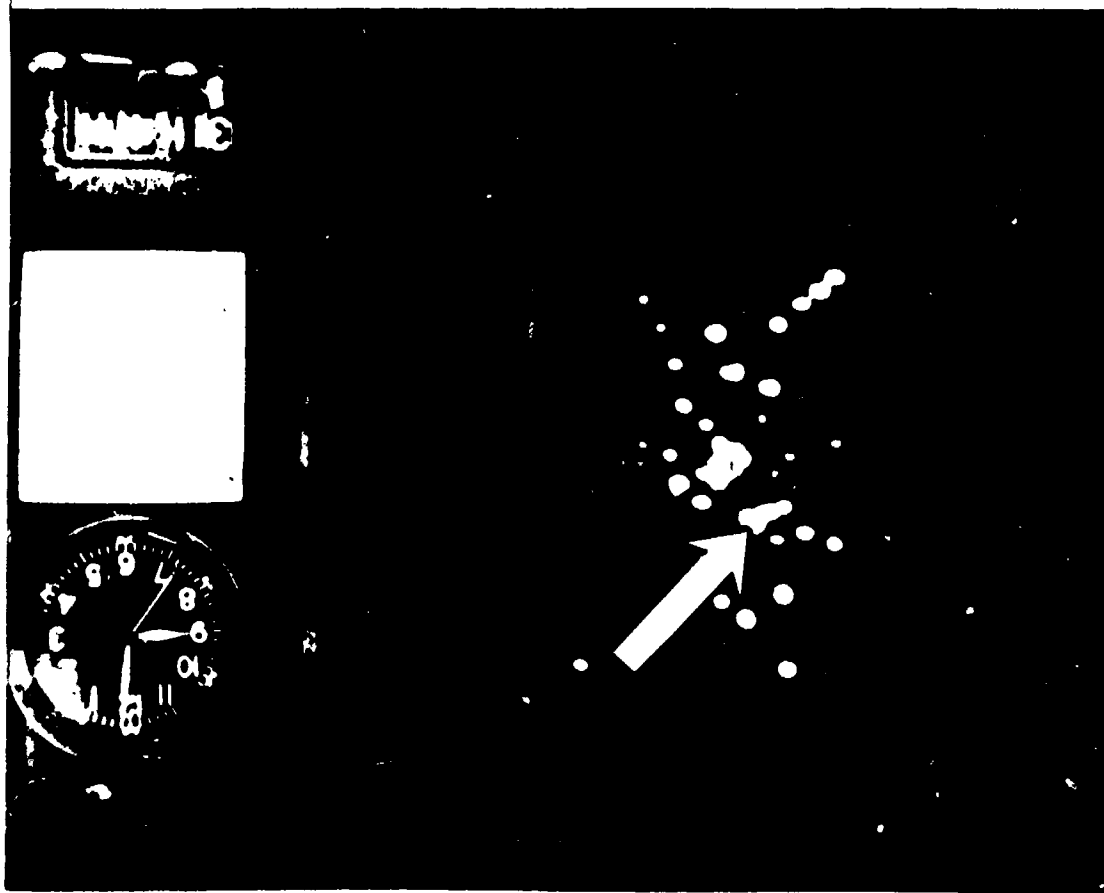
APQ #7 Radar Scope Picture #3141. Target array 8 1/2 seconds after burst. Note 3 pips in place of GILLIAM'S former spot.

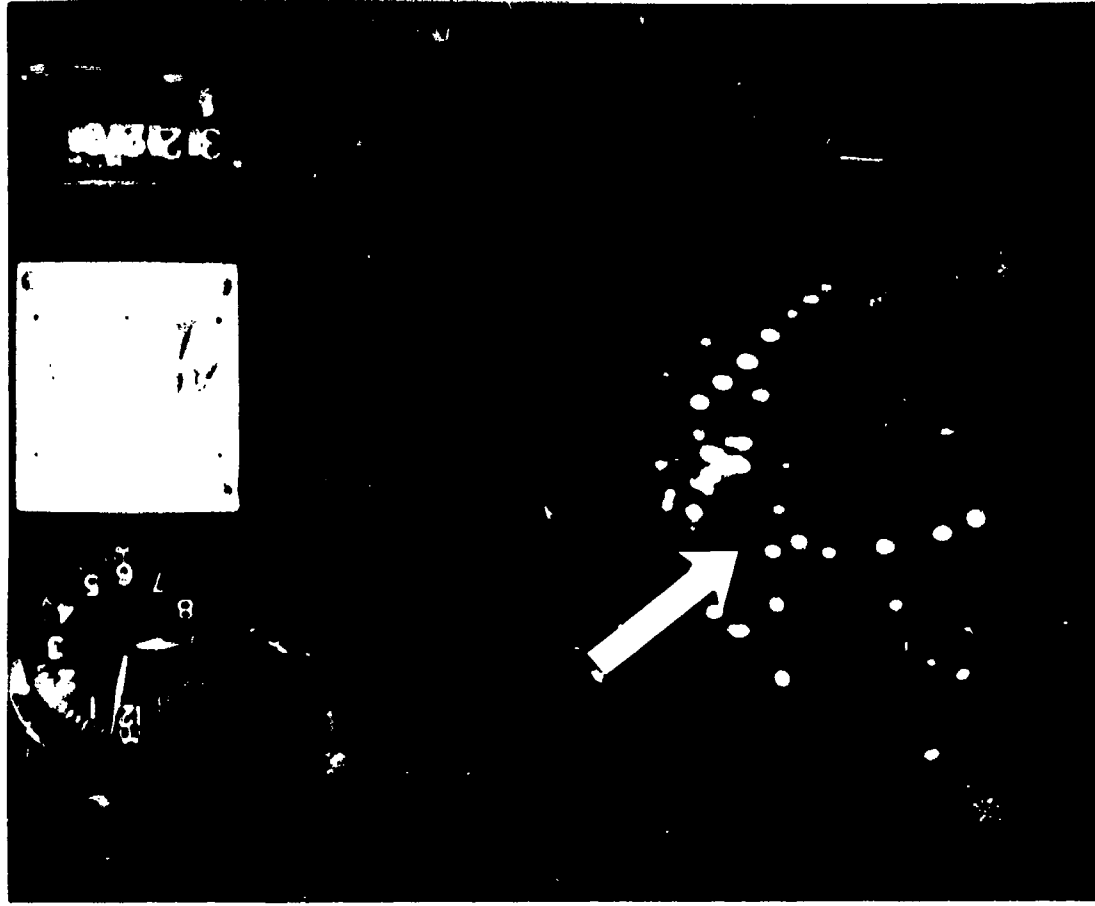
APQ #7 Radar Scope Picture #3220. GILLIAM going down.

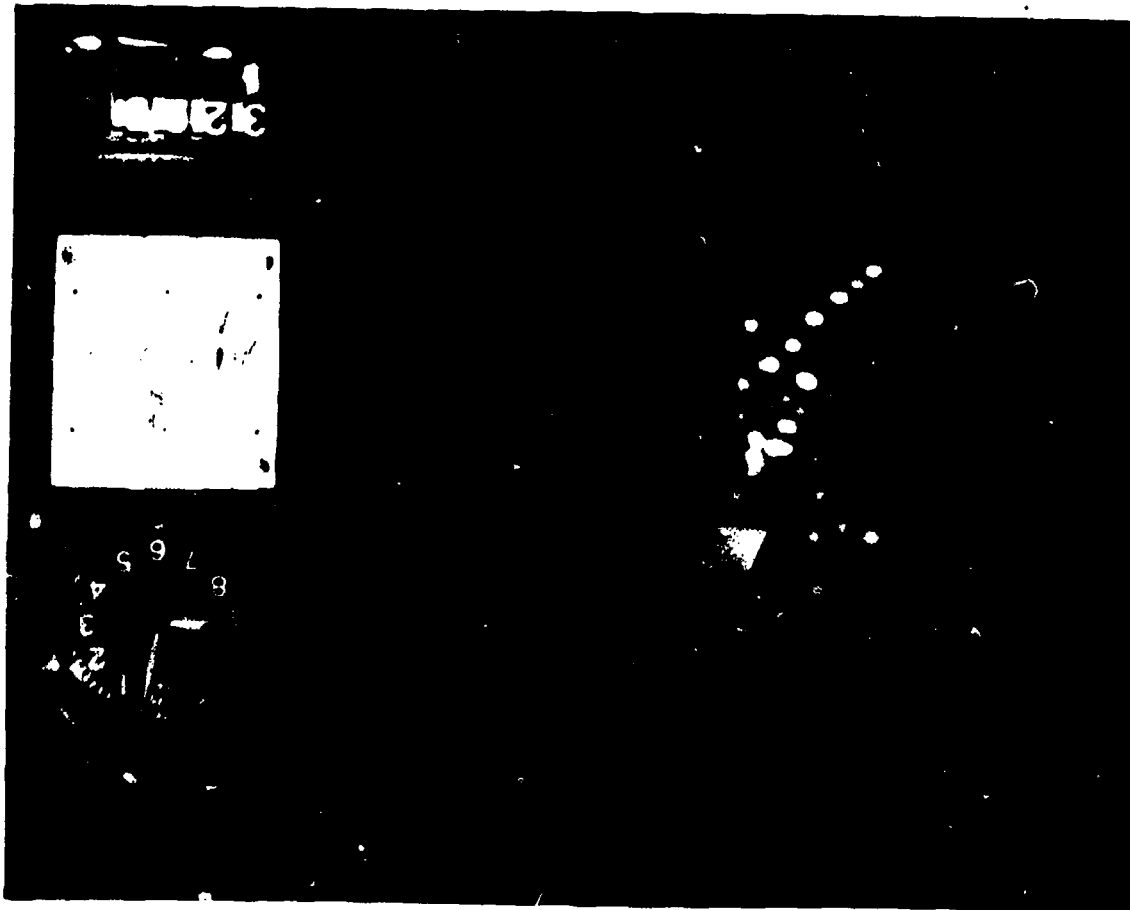
APQ #7 Radar Scope Picture #3225. GILLIAM has disappeared 79 seconds after burst.

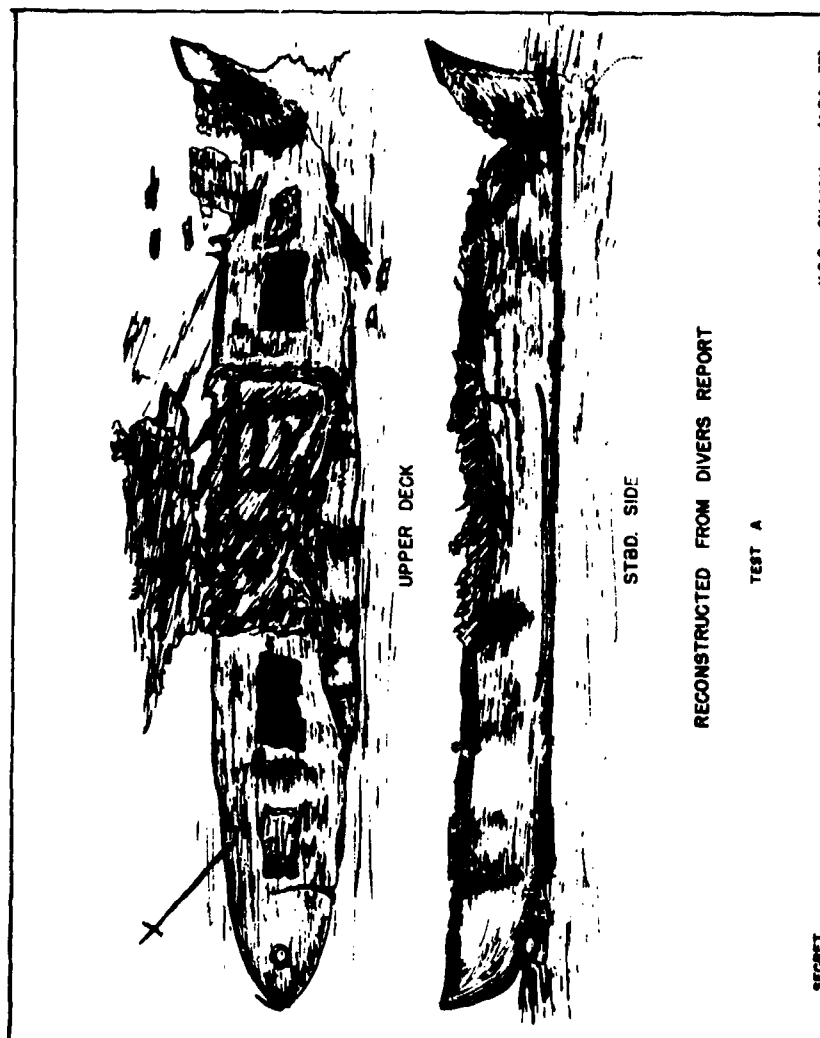
Underwater photographs selected from a total of 60 are included in the picture section of this report. Positive identification of objects shown in the photographs and the orientation on the ship are in most cases very difficult. A sketch of the general damage as reconstructed from diver's reports is shown in sketch on page 38.
